Inspection Report

Property Address:
37 Star Lane
New York NY

Home Detectives of Long Island, Inc.

Date: 3/30/2012	Time:	Report ID: 37 star lane
Property: 37 Star Lane New York NY	Customer: John Doe	Real Estate Professional: Victor Tate Victor Realty

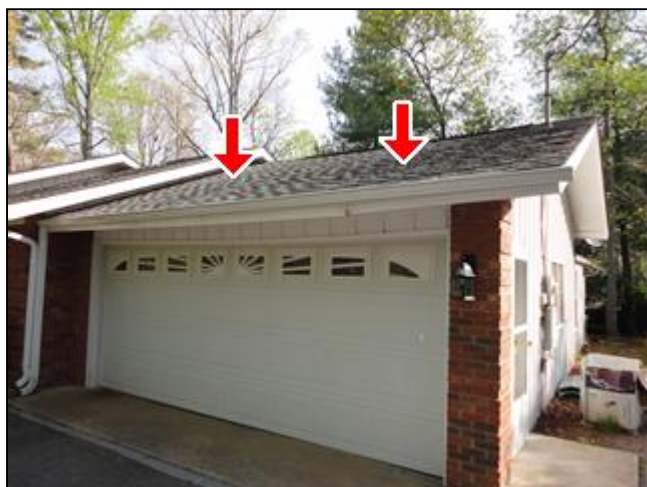
1.0 Item 1(Picture)

- 🔧 (1) Evidence of a leak in the Den below corresponds with the middle skylight roof and flashing area. Repairs are needed. Recommend a qualified contractor inspect further and repair as needed.
- 🔧 (2) The roof covering was installed improperly above garage. Roof sheathing needs to be replaced in this area. This will involve some shingle replacement. A qualified contractor should inspect and repair as needed.

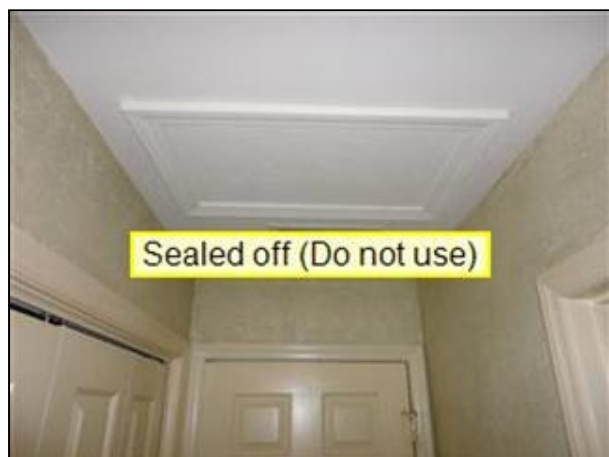
1.5 Item 1(Picture)

No longer an attic access. Use the pull down stairs at garage.

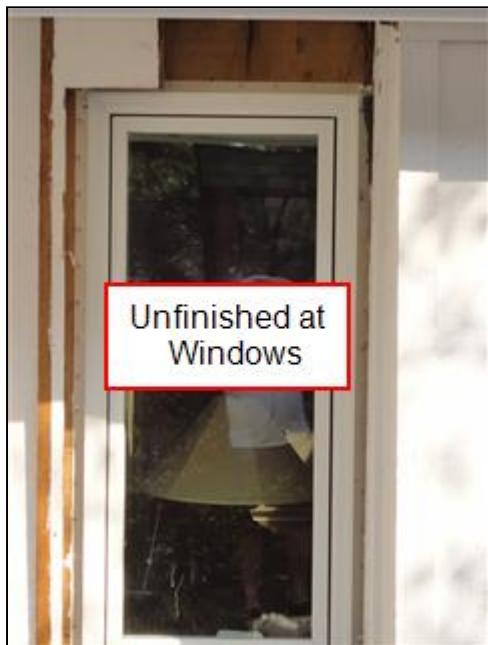
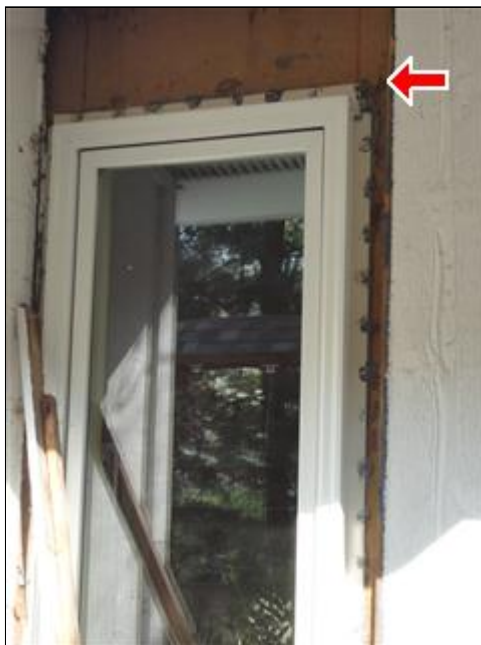
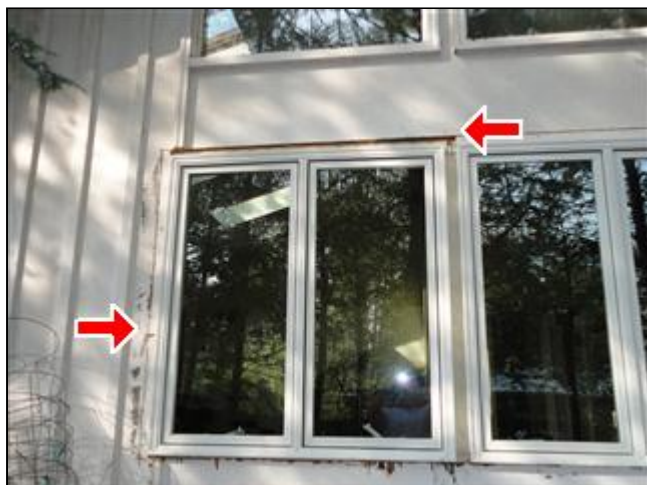
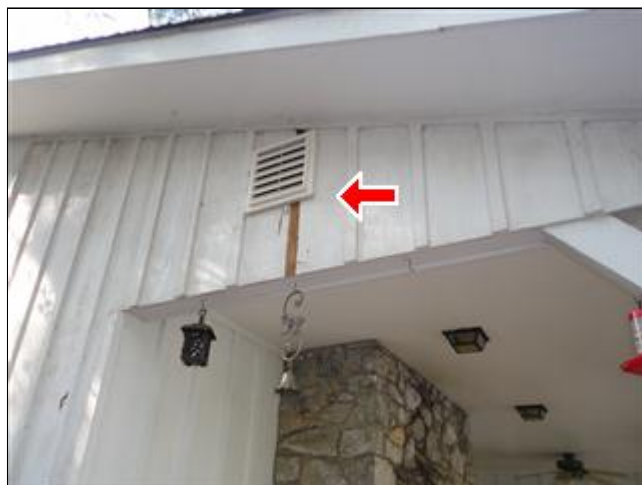
🔨 The Wood siding at the right side (facing front) and rear of home is missing or incomplete at time of inspection around new premium windows that have recently been installed. I did not inspect the installation of siding at this location. A qualified contractor should inspect and repair as needed. The siding will need prep and paint.

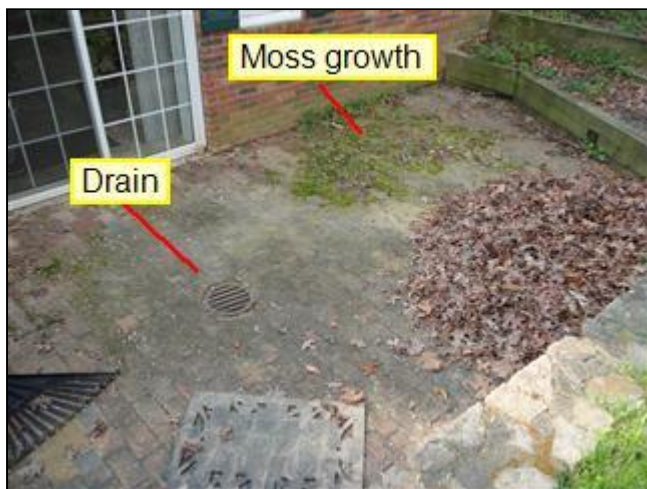
2.4 Item 6(Picture)

🔧 (4) The brick floor on the patio at the left side (facing front) has deteriorated mortar or grout, and is loose and uneven in areas. Water can cause further deterioration if not repaired and sealed properly. A qualified contractor should inspect and repair as needed.

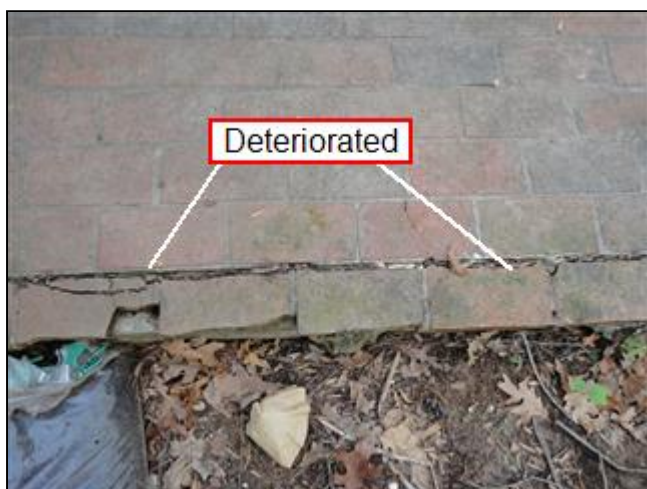
2.4 Item 7(Picture)

- (5) The brick floor on the patio at the rear of home is old and deteriorated. A general replacement is likely. A qualified contractor should inspect and repair as needed.

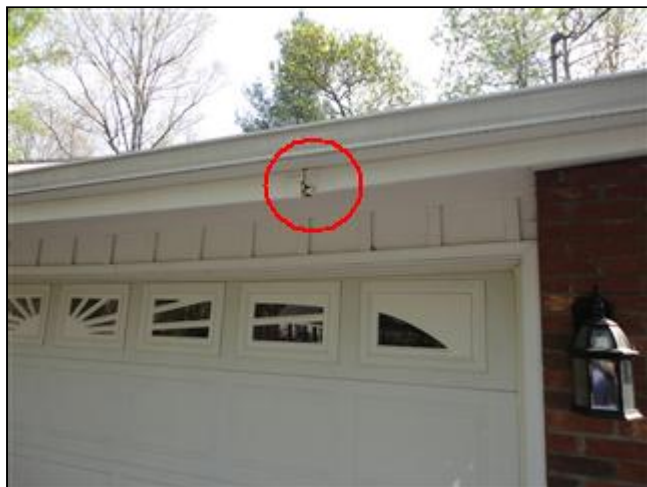
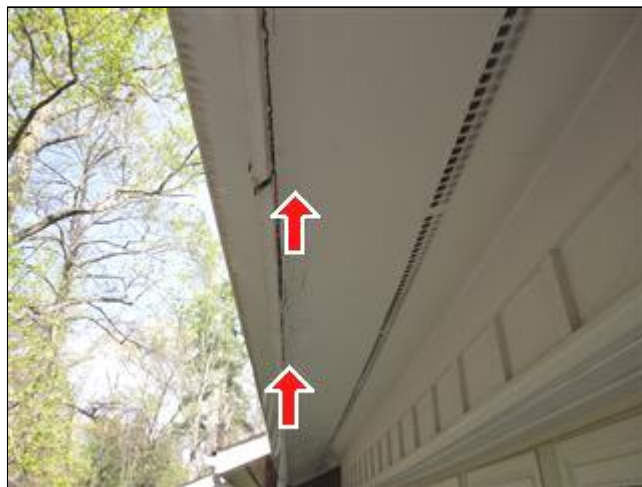
- (1) The wood fascia and soffit panels at eave on the front of home above garage are deteriorated. Repairs are needed to roof covering as well. A qualified contractor should inspect and repair as needed.

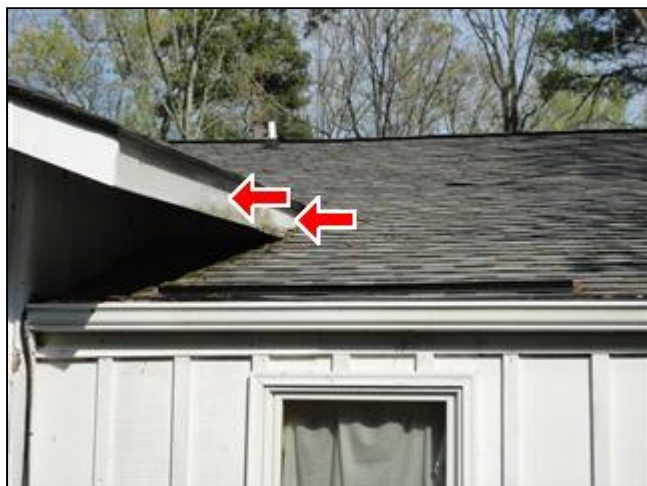
2.5 Item 3(Picture)

- 🔧 (2) The wood fascia at eave on the right side (facing front) is deteriorated. This is a small repair. A qualified contractor should inspect and repair as needed.

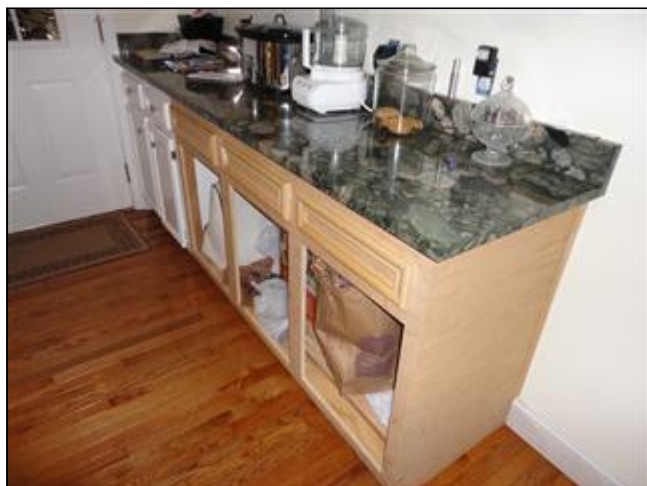
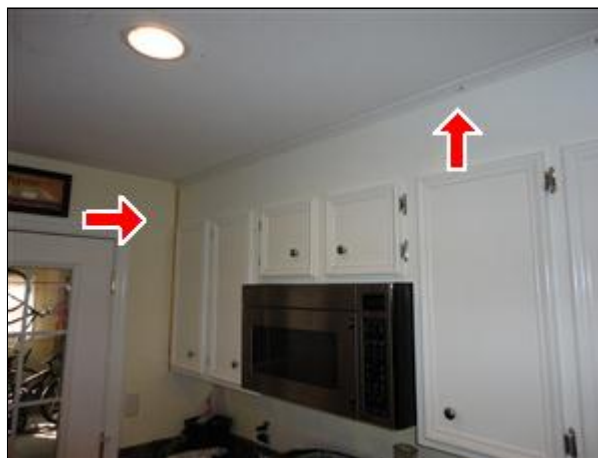
🔧 Base Cabinetry and trim at wall cabinet are unfinished at kitchen.

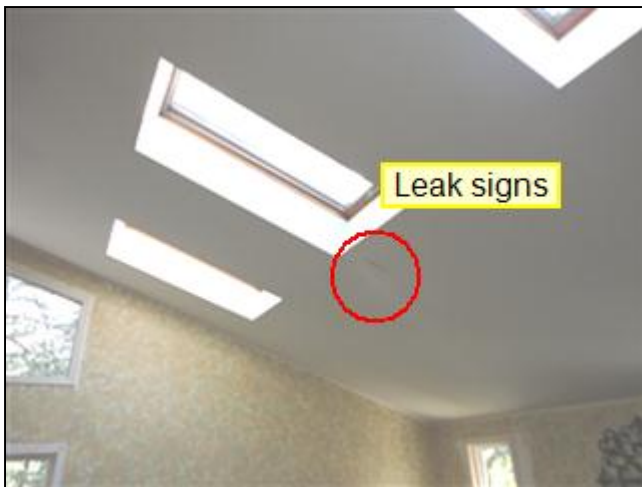
5.0 Item 1(Picture)

- 🔧 (1) The Sheetrock on the ceiling reveals a water stain indicating a leak did or still exists at the Den. Repairs are needed. A qualified contractor should inspect and repair as needed (See Roof Coverings).

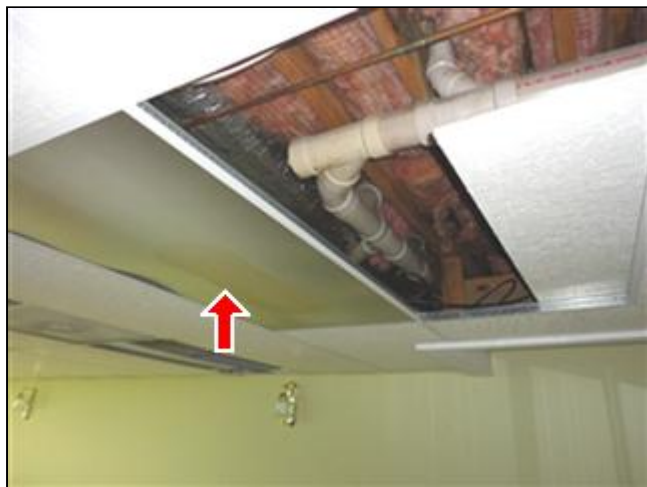
5.0 Item 2(Picture)

- 🔧 (2) Water stain on ceiling panel lower level indicates plumbing leak.

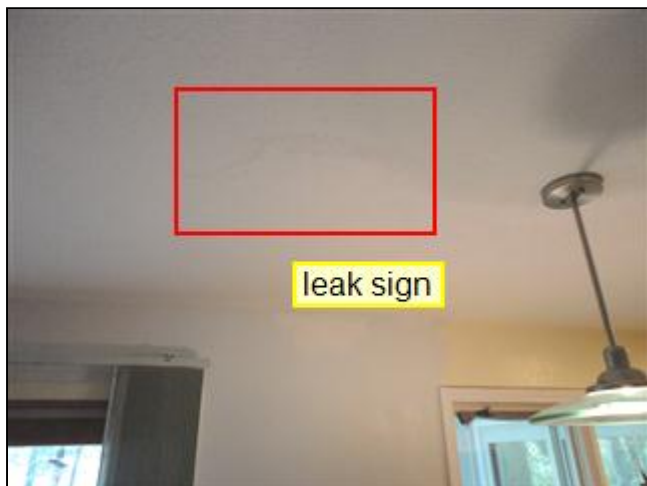
- (3) The Drywall on the ceiling reveals a water stain indicating a leak did or still exists at the Dining Room. Repairs are needed. A qualified contractor should inspect and repair as needed.

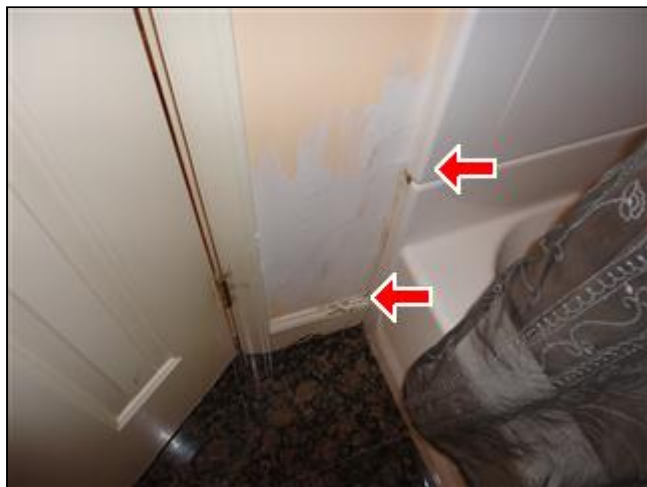
5.1 Item 1(Picture)

- (1) Unfinished around windows in kitchen, and Den.
- (2) The Wall at the bathtub is deteriorated and needs repair or replacement. The wall board and framing may need repair (not visible). I recommend repair or replace using a qualified contractor.

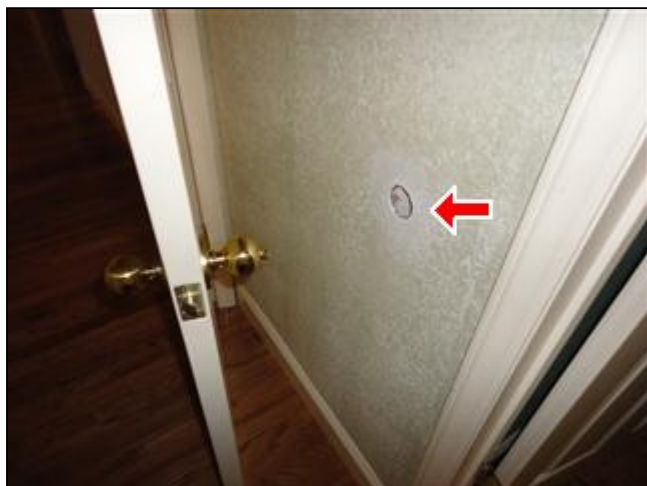
5.1 Item 2(Picture)

- (3) The sheetrock on the wall is dented or damaged from door knob at the hallway. While this damage is cosmetic, it needs to be repaired. A qualified contractor should inspect and repair as needed.

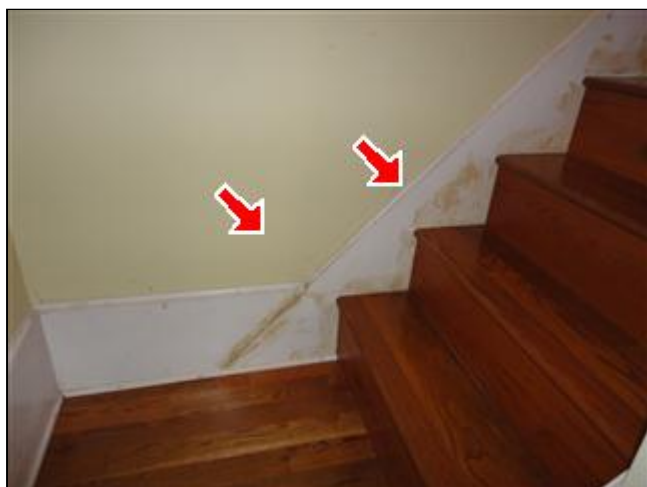
5.1 Item 3(Picture)

- (4) Stair cover trim is unfinished needs prep and paint at stairs.

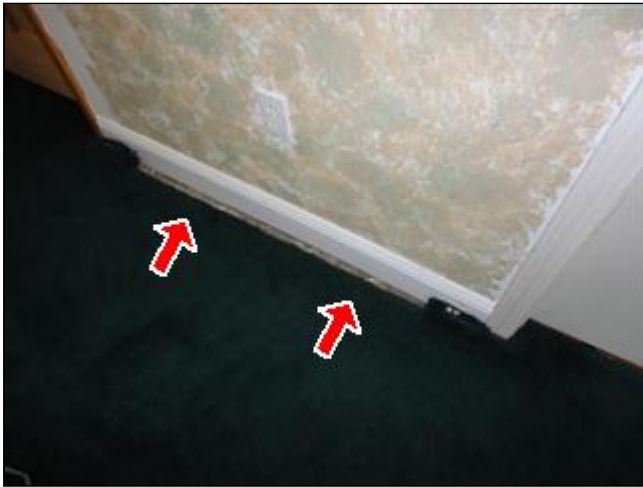
5.2 Item 1(Picture)

🔧 Carpet is loose or cut short from where electric baseboard use to be in areas around the perimeter of the Den.

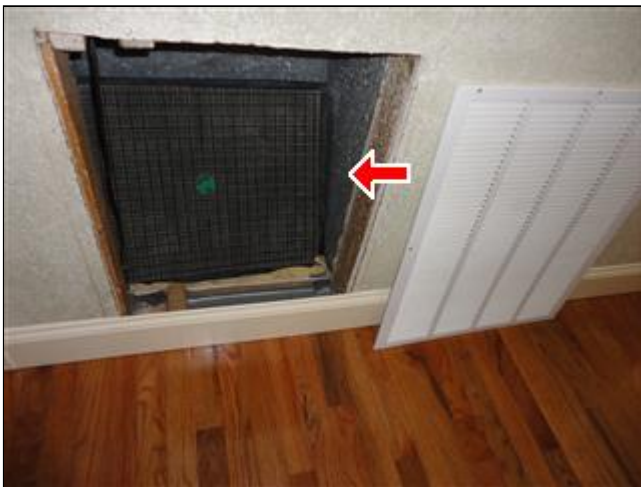
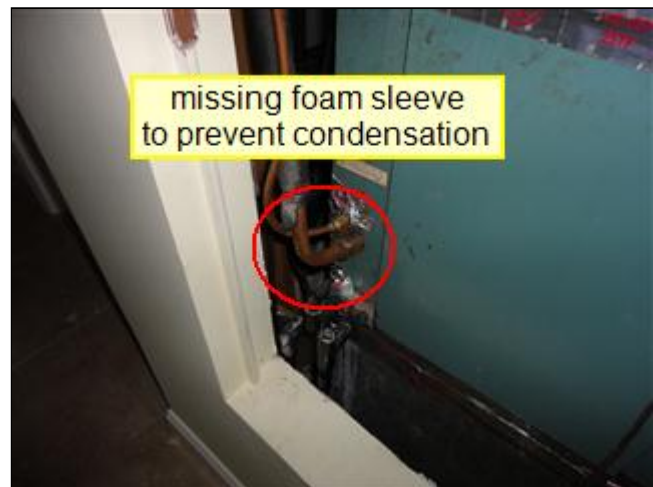
The washable filter is dirty. The filter needs to be cleaned. Recommend foil taping the filter for a better seal. See Video. Foam sleeve missing at suction line creates condensation and drips water.

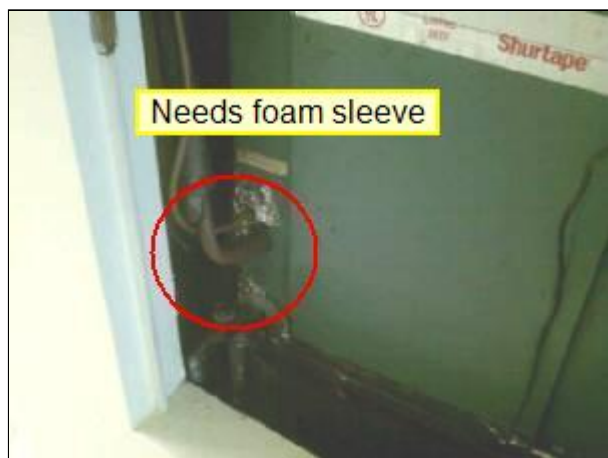
10.8 Item 1(Picture)

Air handler and heat pump is old but appears to be working properly. Foam sleeve on suction line is not covering copper line and condensation can drip.

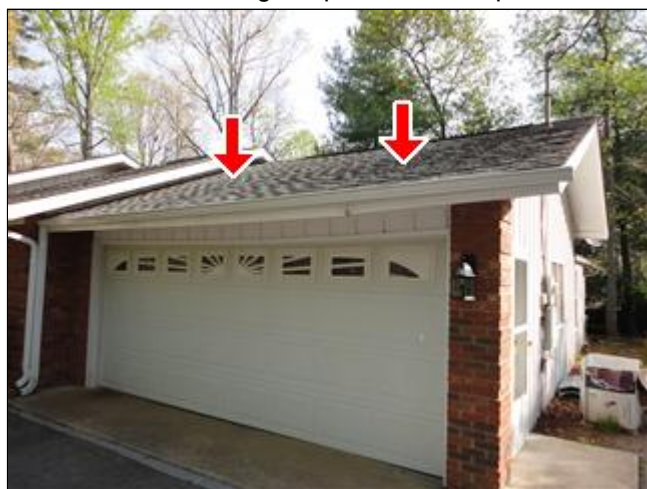
1.0 Item 1(Picture)

(1) Evidence of a leak in the Den below corresponds with the middle skylight roof and flashing area. Repairs are needed. Recommend a qualified contractor inspect further and repair as needed.
-

(2) The roof covering was installed improperly above garage. Roof sheathing needs to be replaced in this area. This will involve some shingle replacement. A qualified contractor should inspect and repair as needed.

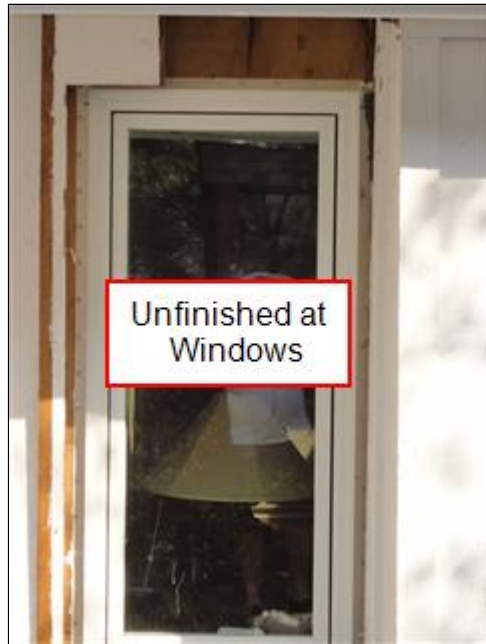
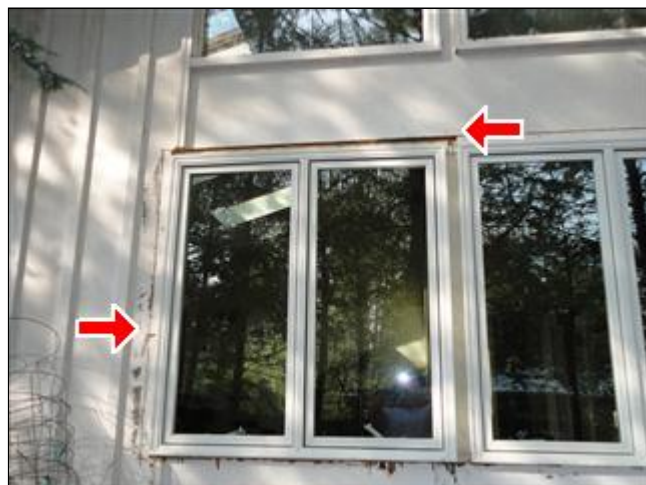
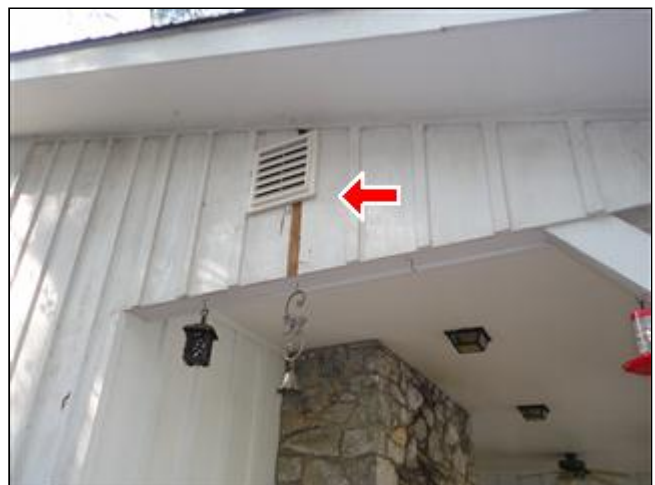
- The Wood siding at the right side (facing front) and rear of home is missing or incomplete at time of inspection around new premium windows that have recently been installed. I did not inspect the installation of siding at this location. A qualified contractor should inspect and repair as needed. The siding will need prep and paint.

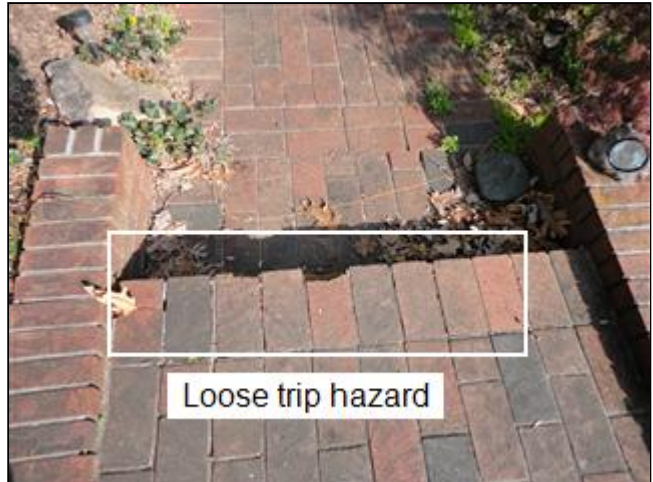
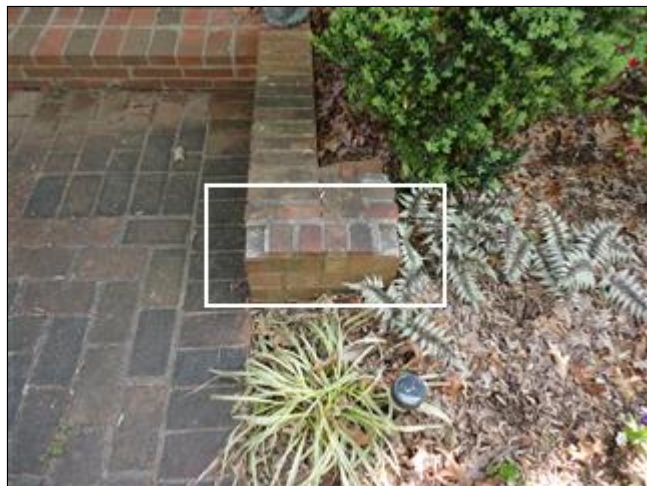
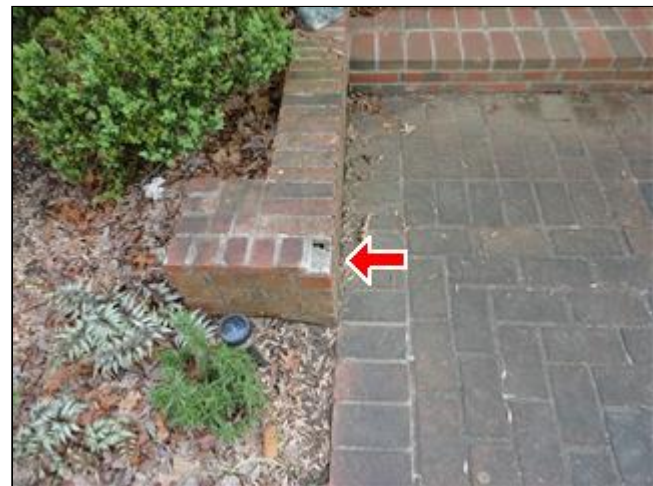
- (1) Possible water run-off from the street into driveway during rain. I am unable to determine the frequency or amount.
- (2) The brick walkway at the front of home are deteriorated in areas. A general replacement is likely. A qualified contractor should inspect and repair as needed.

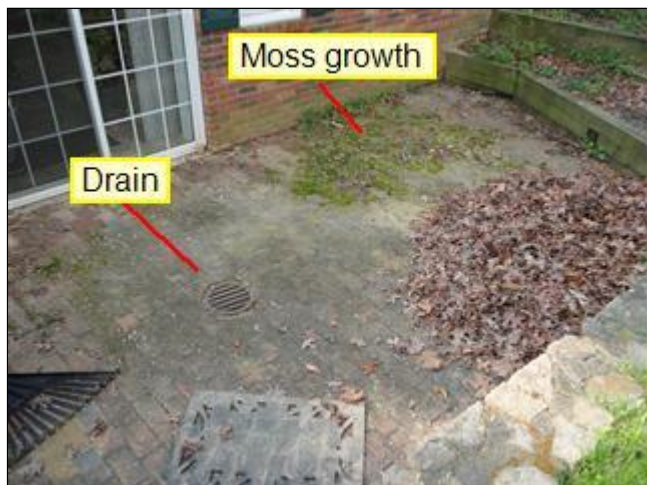
2.4 Item 6(Picture)

- (4) The brick floor on the patio at the left side (facing front) has deteriorated mortar or grout, and is loose and uneven in areas. Water can cause further deterioration if not repaired and sealed properly. A qualified contractor should inspect and repair as needed.

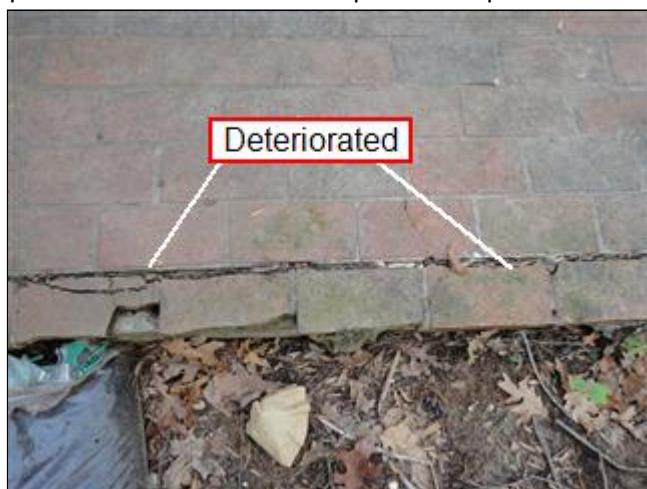
2.4 Item 7(Picture)

(5) The brick floor on the patio at the rear of home is old and deteriorated. A general replacement is likely. A qualified contractor should inspect and repair as needed.

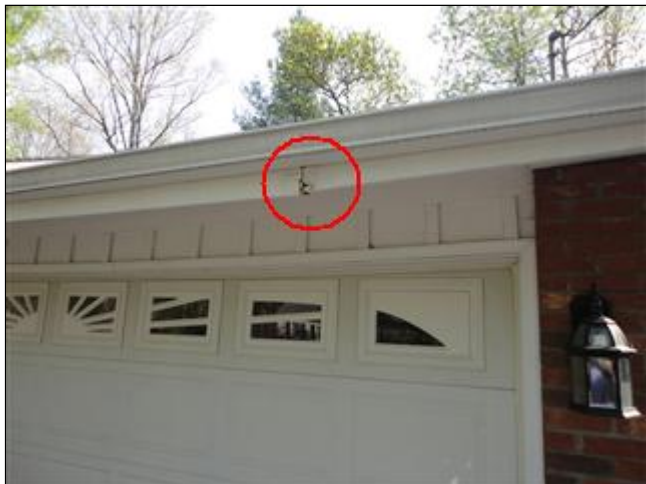
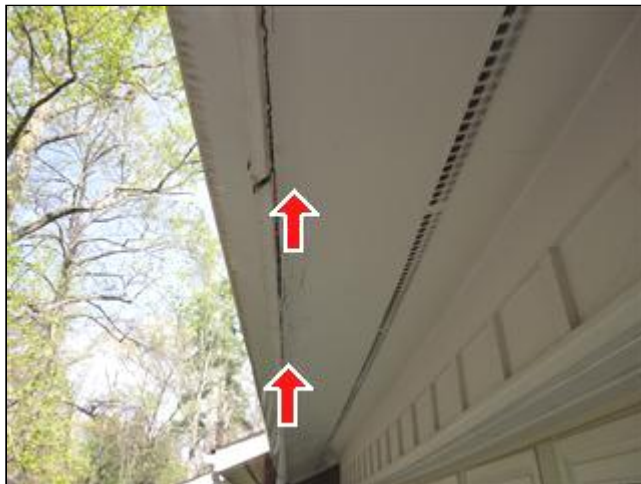
(1) The wood fascia and soffit panels at eave on the front of home above garage are deteriorated. Repairs are needed to roof covering as well. A qualified contractor should inspect and repair as needed.

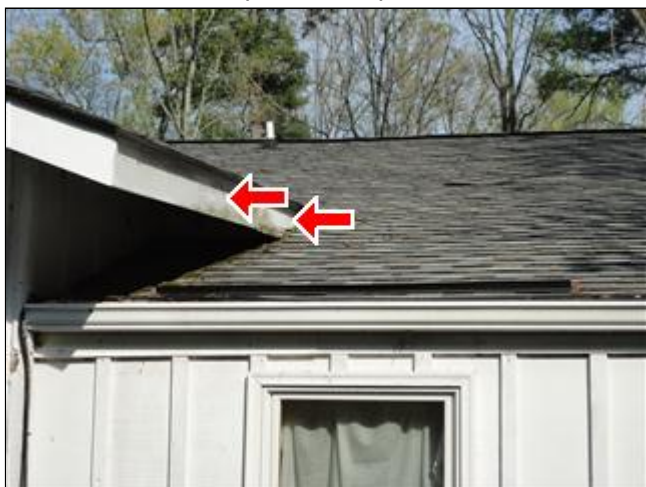
2.5 Item 3(Picture)

(2) The wood fascia at eave on the right side (facing front) is deteriorated. This is a small repair. A qualified contractor should inspect and repair as needed.

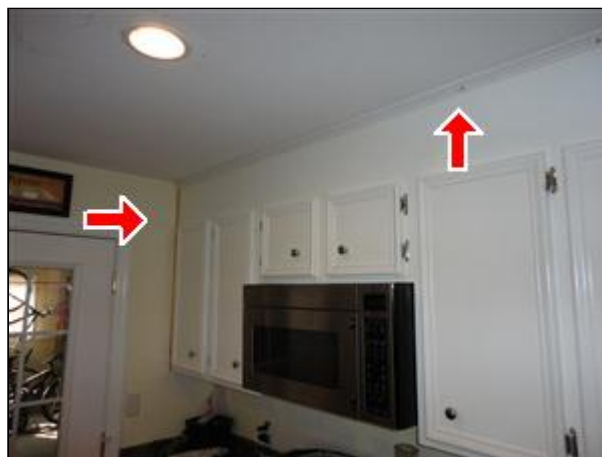
Base Cabinetry and trim at wall cabinet are unfinished at kitchen.

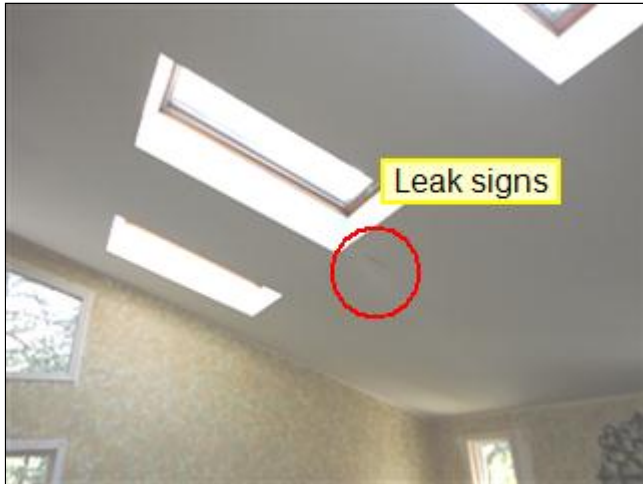
5.0 Item 1(Picture)

- (1) The Sheetrock on the ceiling reveals a water stain indicating a leak did or still exists at the Den. Repairs are needed. A qualified contractor should inspect and repair as needed (See Roof Coverings).

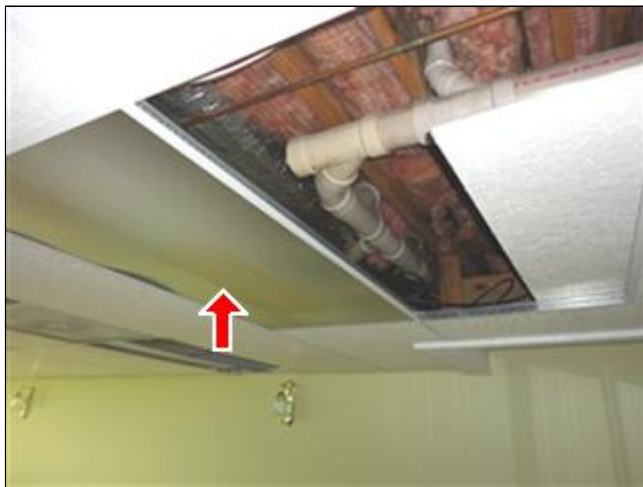
5.0 Item 2(Picture)

(2) Water stain on ceiling panel lower level indicates plumbing leak.

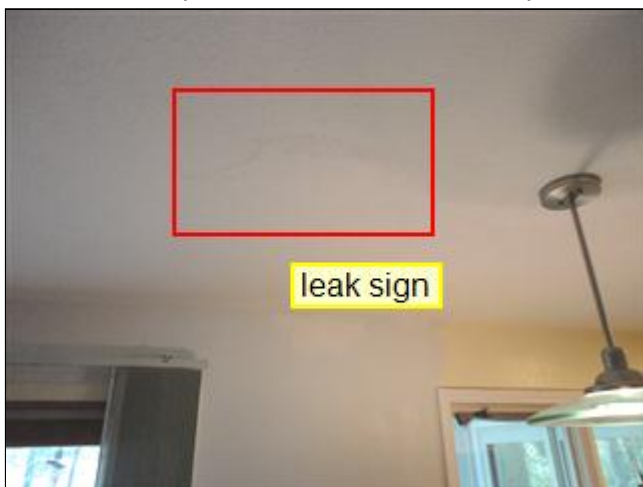
(3) The Drywall on the ceiling reveals a water stain indicating a leak did or still exists at the Dining Room. Repairs are needed. A qualified contractor should inspect and repair as needed.

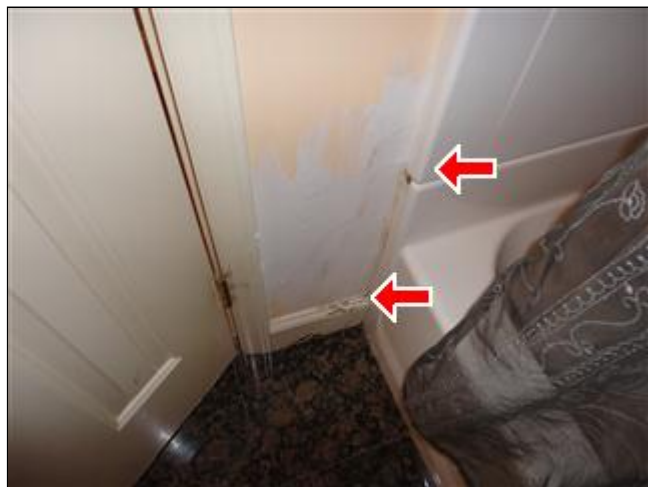
5.1 Item 1(Picture)

- 🔧 (1) Unfinished around windows in kitchen, and Den.
- 🔧 (2) The Wall at the bathtub is deteriorated and needs repair or replacement. The wall board and framing may need repair (not visible). I recommend repair or replace using a qualified contractor.

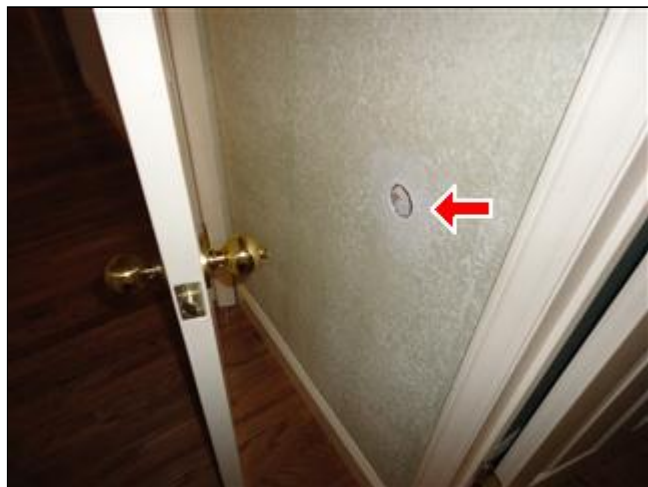
5.1 Item 2(Picture)

- 🔧 (3) The sheetrock on the wall is dented or damaged from door knob at the hallway. While this damage is cosmetic, it needs to be repaired. A qualified contractor should inspect and repair as needed.

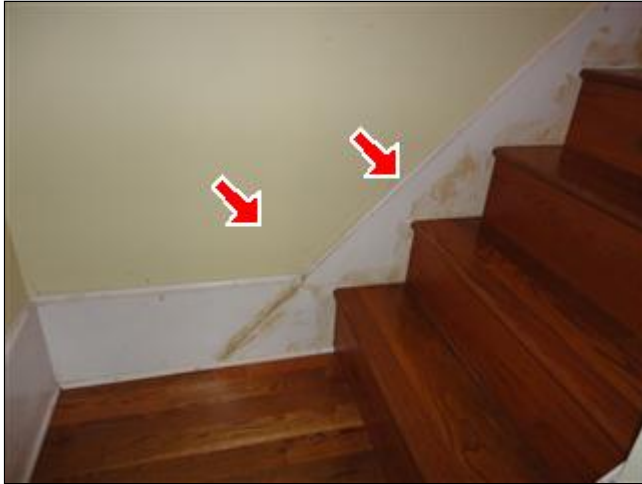
5.1 Item 3(Picture)

- 🔧 (4) Stair cover trim is unfinished needs prep and paint at stairs.

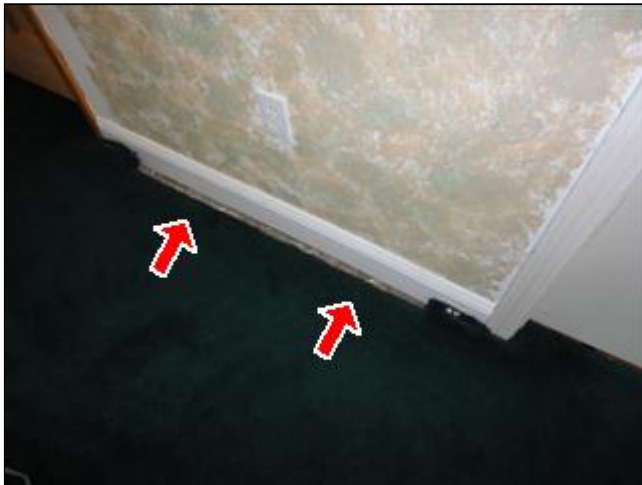
5.2 Item 1(Picture)

Carpet is loose or cut short from where electric baseboard use to be in areas around the perimeter of the Den.

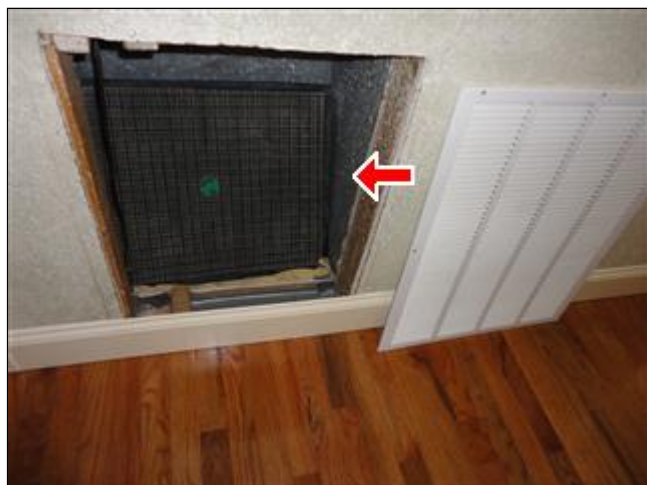
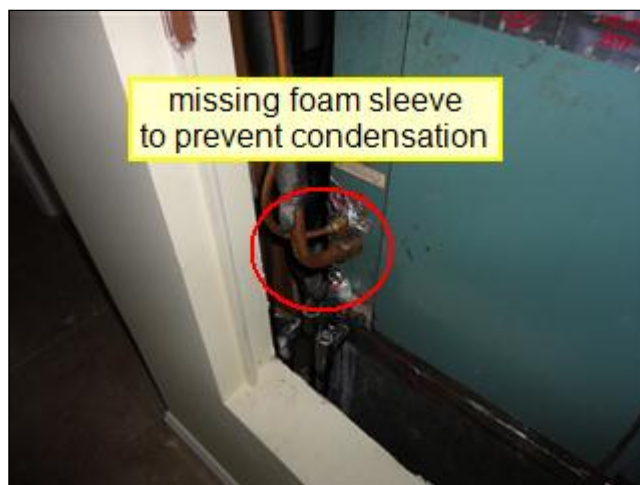
The washable filter is dirty. The filter needs to be cleaned. Recommend foil taping the filter for a better seal. See Video. Foam sleeve missing at suction line creates condensation and drips water.
